Investigation of Fiberglass-Reinforced Plastic (FRP) Condensate Return Carrier Piping

by
Orange S. Marshall, Jr. and Charles P. Marsh

REFERENCE: USACERL Technical Report 98/26, Investigation of Fiberglass-Reinforced Plastic (FRP)

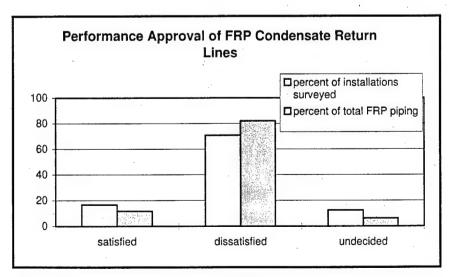
Of the engineers and technicians surveyed who were knowledgeable about the performance of FRP condensate carrier pipe systems at their respective installations, 16. 7 percent said they liked FRP carrier piping. This corresponds to 11.7 percent of the total FRP condensate carrier piping by length used by the Federal agencies surveyed. Of those remaining, 70.8 percent of the installations surveyed (82.0 percent by length of pipe) said that they hated FRP pipe and would never willingly specify it again. The remaining 12.5 percent (6.2 percent by pipe length) were undecided. Those who stated that they liked FRP pipe for condensate return cited the following advantages of using that type of pipe over steel: (1) ease of installation, (2) ease of maintenance, and (3) the freedom from the requirement to join the pipe with welds (Figure 1). The overall ratio of dissatisfied installations to installations satisfied with the performance of FRP condensate pipes is 4.2:1 (6.9:1 by pipe length).

Figure 1. Performance approval of FRP condensate return carrier lines.

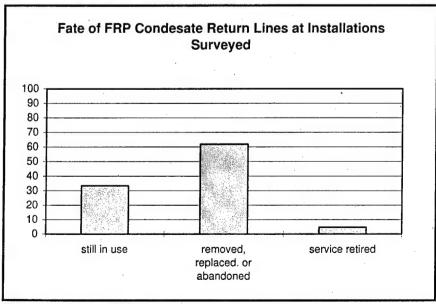
Many of the surveyed installations stated that all or part of the installed FRP condensate carrier pipe had been either removed or abandoned. Two installations (4.7 percent of the installed pipe) had abandoned the facilities that the FRP carrier pipe serviced and, as a result, the associated carrier pipe as well. Of the other 22 Federal agencies surveyed, only 43.5 percent were still using the installed FRP carrier pipe. This corresponds to 33.4 percent of the installed carrier pipe still being used and 61.9 percent removed, either replaced with steel piping or abandoned in place (Figure 2). Some agencies (13.0 percent) had replaced the FRP pipe with steel pipe in shallow trenches, and 17.4 percent had installed individual unit boilers in buildings previously serviced by FRP pipe.

Figure 2. Fate of FRP condensate return lines.

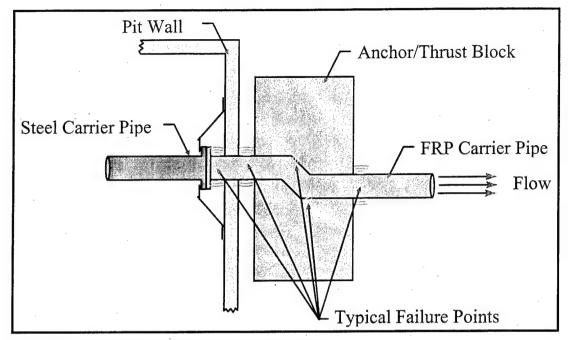
When the FRP pipe breaks, it is typically either in or within a few inches of the manholes or the concrete anchors (Figure 4). This may have several causes, including: (1) settling of the manholes and anchors over time, (2) settling of the anchor and not the manhole, or vice versa, (3) ground heave from freeze-thaw in cold climates, (4) thermal expansion and contraction of the pipe, or (5) a combination of two or more of any of these. When the pipe breaks, a significant

Figure 4. Typical failure points around manholes.

length of adjacent pipe is also damaged, requiring additional excavation and testing to find sound pipe to attach a repair section of pipe to.

A typical repair takes two or three men, a backhoe operator, a laborer, and a mechanic 8 to 10 hours to complete. This type of repair at or near a manhole consists of the following steps:

- 1. Turning the system off (and waiting for it to cool down)
- 2. Unbolting the flange in the manhole
- 3. Cutting out the concrete thrust block
- 4. Excavating the FRP pipe back to a point where it is round, and cutting it off there
- 5. Reaming the end and adding a flange to the FRP pipe
- 6. Running steel pipe for cut out portion of FRP pipe
- 7. Flanging both ends of the steel replacement
- 8. Bolting up the flanges
- 9. Turning the system on and checking it for leaks
- 10. Replacing the dirt fill (and doing any landscaping).

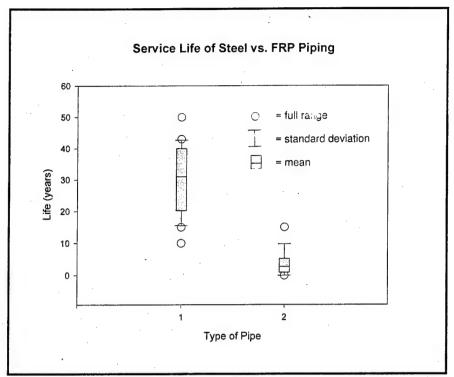
The life of steel pipe cited by the installations for carrying boiler condensate water had a mean of 30.6 years, with a standard deviation of \pm 9.44 years, and a median of 31 years. The range of life span cited varied from 10 to 50 years. Figure 5 shows the results of a comparison, based on the survey, of the life of FRP and steel condensate carrier pipes. Figure 6 shows the differences in service life between the two types if piping by installation for those installations who provided this type of data. (Note that Installation 1 has highly acidic soil.)

Figure 5. Life comparison between FRP and steel condensate carrier pipes.

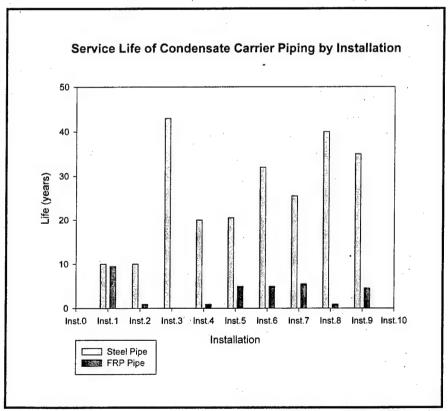
Figure 6. Service life comparison of steel vs. FRP piping by installation.
